# The Life Cycle of Your Roof

Homeowner's Guide: What to Expect From Your CertainTeed Roof

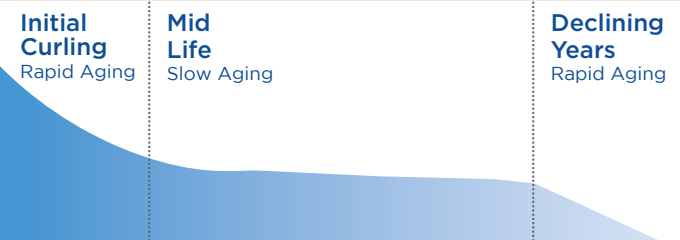
When your new roof was installed, friends and neighbors may have remarked how it enhanced the beauty of your home. However, research indicates that aging begins soon after the shingles are installed and progresses rapidly during the initial curing phase of its life cycle. During this stage, granule loss may occur, small blisters may develop, or the shingles may curl slightly at their edges. You may even notice that this curling is more pronounced during cold weather and the shingles may lie flat as temperatures rise. The good news, however, is that after this curing stage the shingles enter a long period of slow aging, which lasts for the major portion of the shingle's natural life.

During the “mid-life” period, aging continues at a much slower rate. The cracking or granule loss still occurs but does not increase at a noticeable rate. Only after this long period of mid-life does the aging process begin to accelerate once again as the shingles enter their declining years. It’s during this period that homeowners normally think about replacing their roofs.

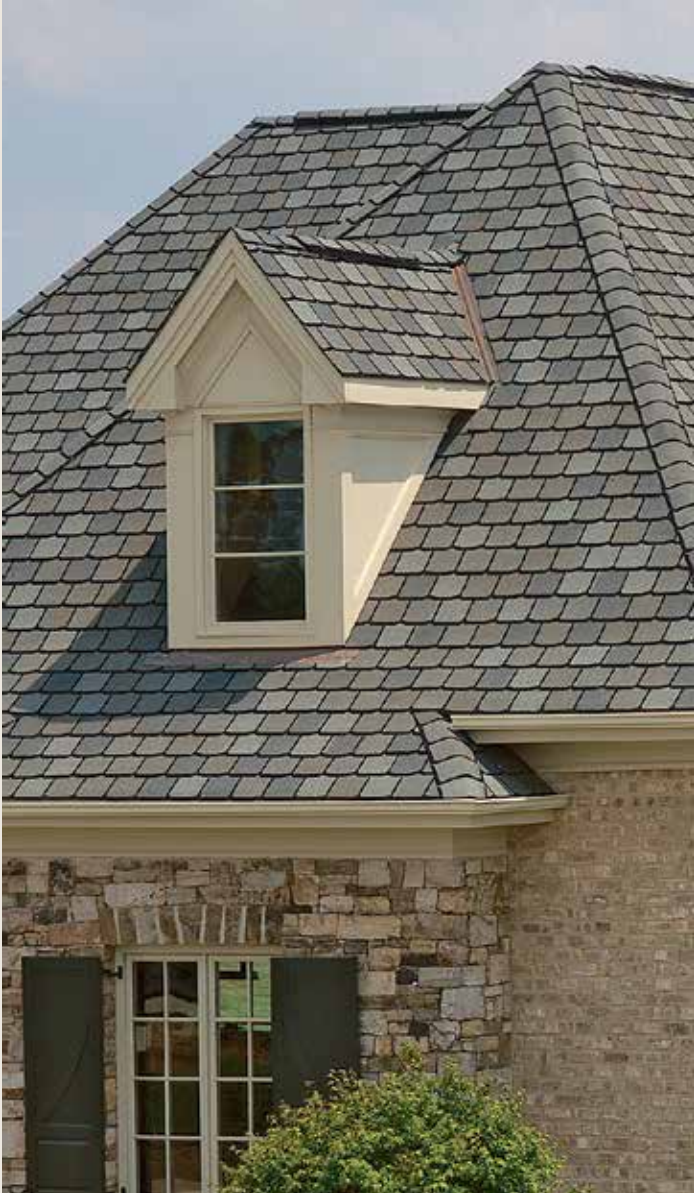
## CURLING

**CURLING:** As the asphalt hardens over time, the granules which were once securely embedded begin to break away. Occasionally you may have seen the colored granules in your gutters. Also, as this hardening advances, the asphalt layers begin to shrink. Of course, all of this is occurring at a microscopic level and is not something which will be noticeable on a daily basis. As the asphalt layer shrinks, it is being countered by the shingle reinforcement, which resists shrinking. We now have a situation in

which the top and bottom coatings are shrinking and the reinforcement is remaining stable. As a result, the edges of the shingle may begin to curl over time. In addition, organic shingles may exhibit signs of curling which might be considered excessive, however, this is not a manufacturing defect and would be considered part of the normal weathering process of organic shingles.
